Subject: PROLENE\* (POLYPROPYLENE) MICROCRACKS

Subject: HUMAN RETRIEVAL SPECIMENS FROM DR. ROGER GREGORY, NORFOLK SURGICAL GROUP

Subject: EXAMINATION OF 5/0 AND 6/0 CARDIOVASCULAR PROLENE\* SUTURES EXPLANTED AFTER 2 TO 6 YEARS IMPLANTATION

EXAMINATION OF PROLENE\* (POLYPROPYLENE) SUTURES FROM HUMAN CARDIOVASCULAR EXPLANTS

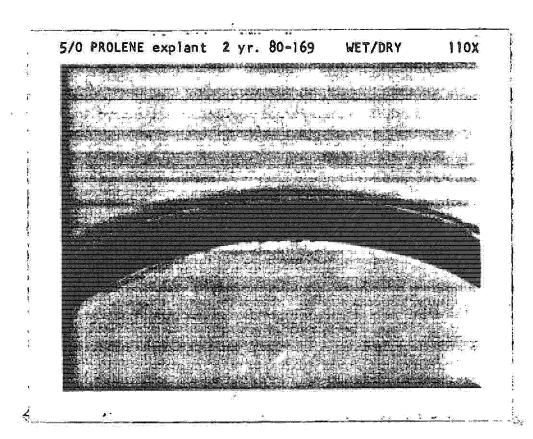
No cracks when kept in the wet state. Cracks develop upon drying under ambient conditions

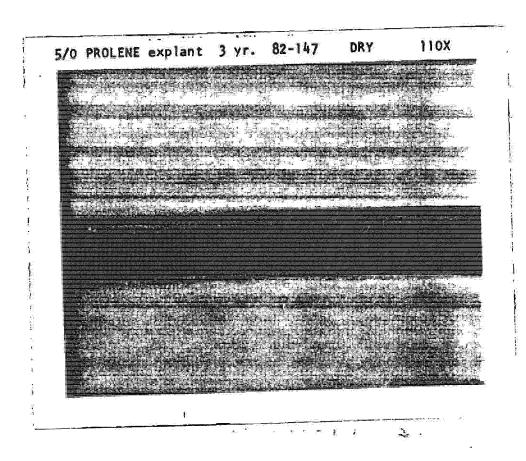
All but one of the dry storage samples exhibited surface cracks. The severity of the cracking is directly related to time the sutures were implanted.

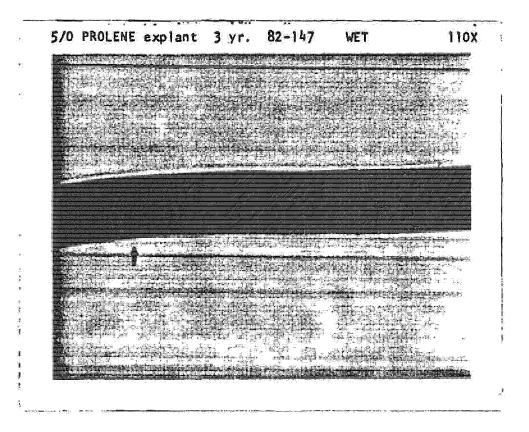
A few tiny cracks (arrow) were found in the wet filament. Many cracks appeared as a result of drying at ambient temperature (below)

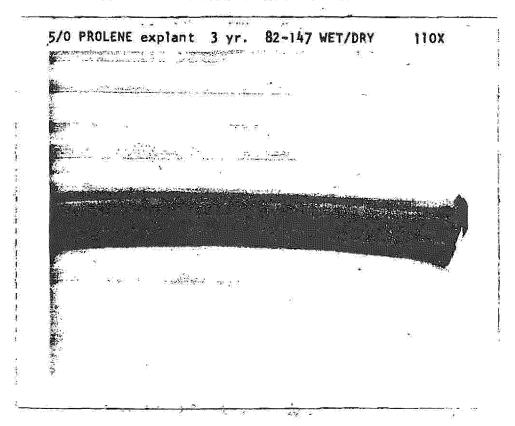
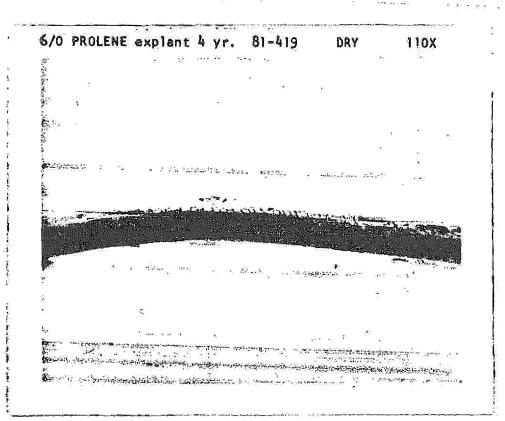
These pictures illustrate the increase in the severity of cracking with time of implantation.

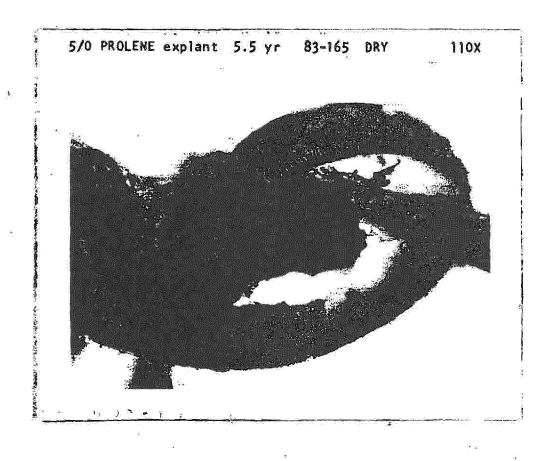
After 6 years implantation, the suture above was explanted and allowed to dry. It shows cracks. The suture below was implanted for the same time but was never allowed to dry. It is not cracked.

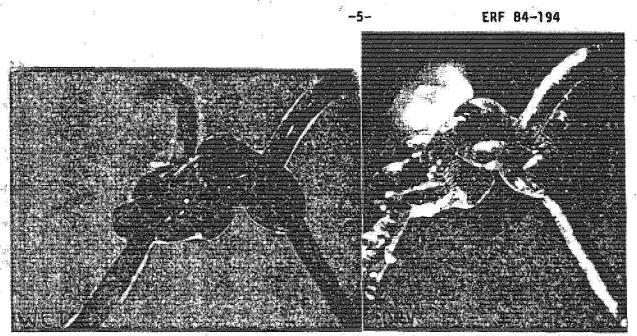
Sample 6 showed evidence of severe surface cracking by light microscopic examination. The appearance of the cracked layer was not always apparent when the specimens were examined in a wet condition but were dramatically evident in dry segments of identical areas, Figure 1 & 2. However, one sample did show evidence of a cracked layer when wet and dry, Figure 3. The cracked surface layer appeared blue when examined against a light colored background, Figure 4.

Figure 1 - Knot from sample 6 examined under wet and dry conditions. Cracking is more readily apparent in dry samples, 7 years size 5-0, magnification x40.

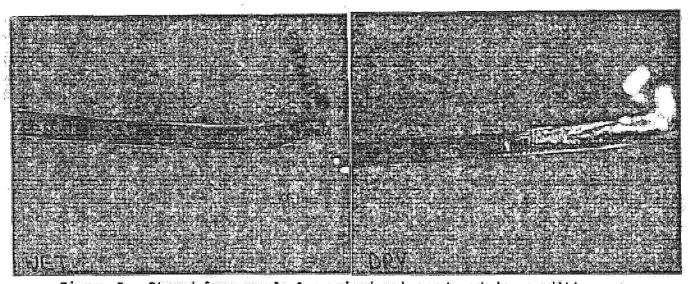
Figure 2 - Strand from sample 6 examined under wet and dry conditions. Cracking is more readily apparent in dry samples, 7 years, size 5-0, magnification X40.

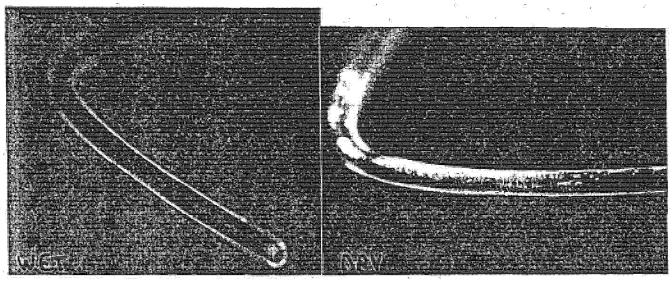
Figure 3 - Sample 6 examined under wet conditions showing some evidence of surface cracking which is more dramatic in the dry sample, 7 years, size 5-0, magnification x40.

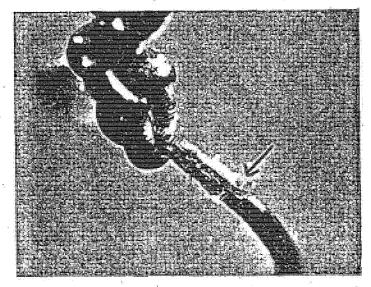
of the cracked layer over time. The cracked layer appeared blue in gross specimens and blue dye particles were evident in histological sections of the layer. This would indicate that the layer is dyed PROLENE polymer and not an isolated protein coating on the strands.

Figure 4 - Sample 6 photographed against a white background showing the blue color of the cracked surface layer, 7 years, size 5-0, magnification x40.
